# Home Inspection Report

[REDACTED]  
[REDACTED]  
Prepared By: Ramon Marte

15:42 January 06, 2023

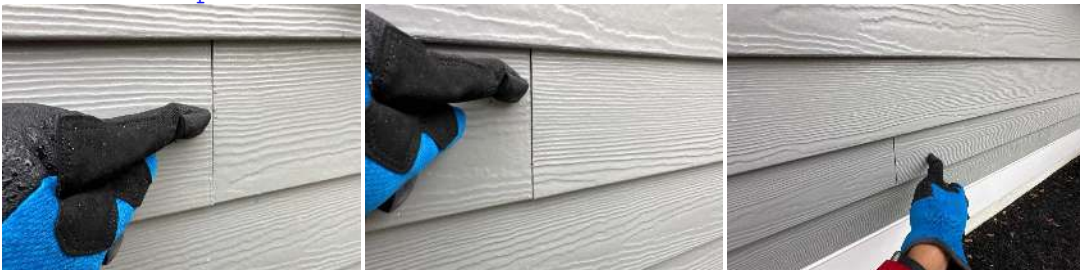
1. ☒☐☐☒☐ Type: Cement Board ( Hardy Planks ). Loose and not caulked. It is good building practice to seal the joints to prevent moisture, such as wind-driven rain and snow, from penetrating the wall cavity. Caulking around windows, doors, eaves and trim edges gives added insurance that leaks will not occur. Recommend a contractor be hired to evaluate and estimate repairs.

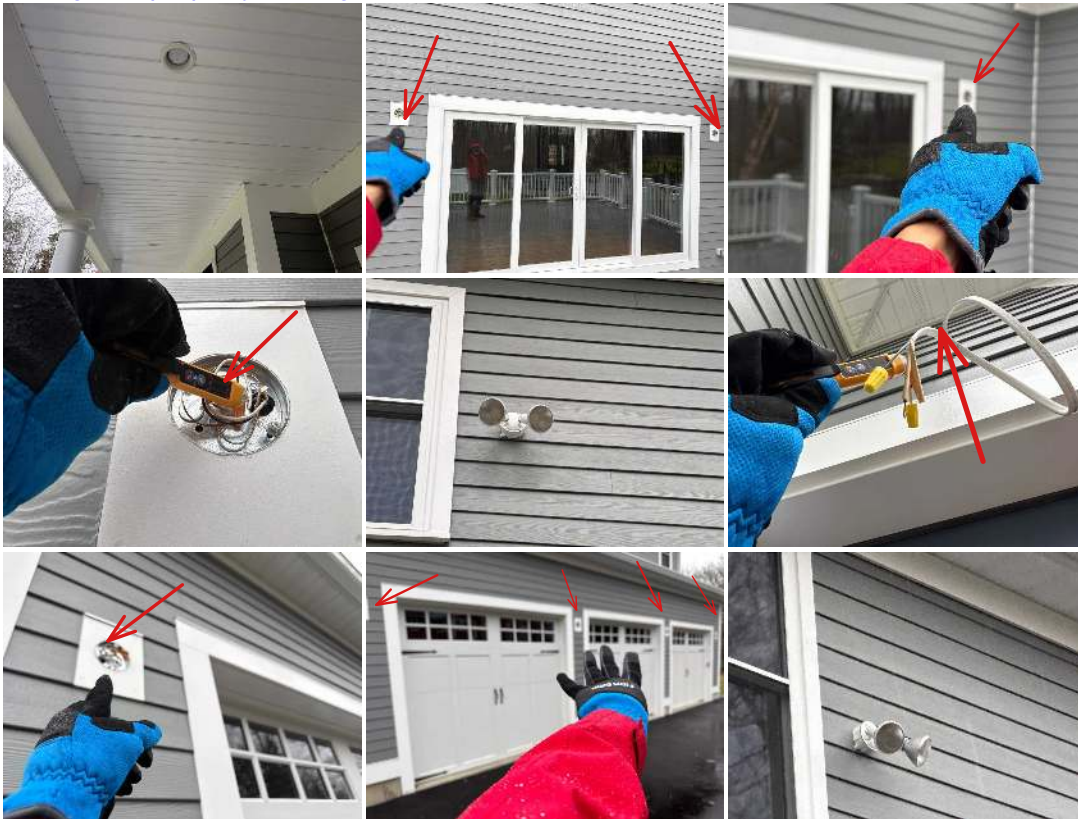
12. ☐ ☐ ☐ ☒ ☐ Exterior Lighting: Surface mounted lamps front and rear - **Exposed wiring at several locations throughout property. Hiring a license electrician is recommended to evaluate and estimate repairs.**

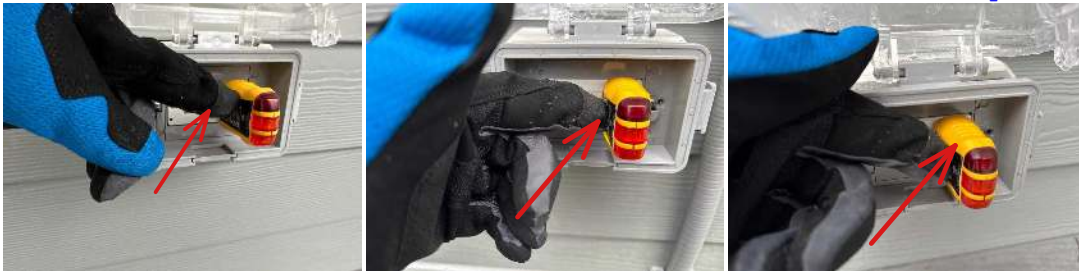
13. ☐☐☒☐☐ Exterior Electric Outlets: 110 VAC GFCI - Outlet would not reset when tripped and tested, Confirm at electrical panels no tripped breakers? recommend a license electrician be hired to evaluate and estimate repairs.

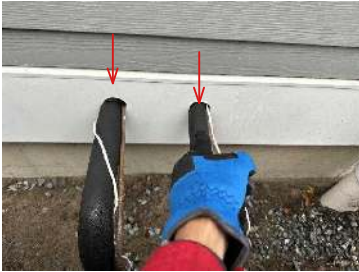
21. ☐☐☒☒☐ Refrigerant Lines: Low pressure and high pressure - [Entry point not sealed!](#)

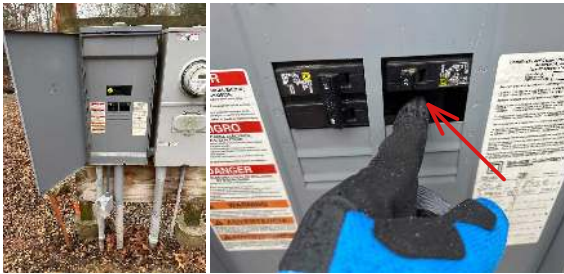
12. ☒ ☒ ☐ ☐ ☐ Fuses: None Present.
13. ☒ ☒ ☐ ☐ ☐ AFCI: None Present.
14. ☒ ☐ ☐ ☐ ☐ GFCI: At GFCI receptacles only
15. Is the panel bonded? ☒ Yes ☐ No
- Sub Paneling is located in the exterior Electric Panel \_\_\_\_\_
16. ☐ ☐ ☐ ☒ ☐ Manufacturer: Square D - [Open knock-out hole- insert blank-out cap to close off opening.](#)  
[Evaluation by a licensed electrician is recommended](#)

[Electrical service panel box cover was remove due to rain.](#)

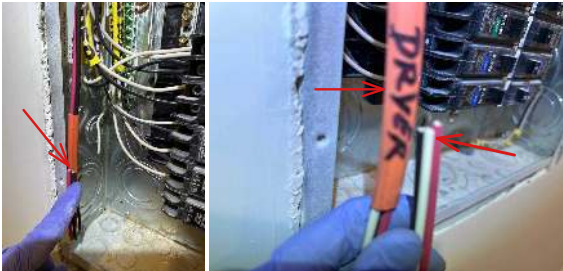
35. ☐ ☐ ☐ ☒ ☐ Breakers: 12 singles - [Expose wiring missing wire retaining screw cap. Recommend a licensed electrician be hired to evaluate and estimate repair.](#)

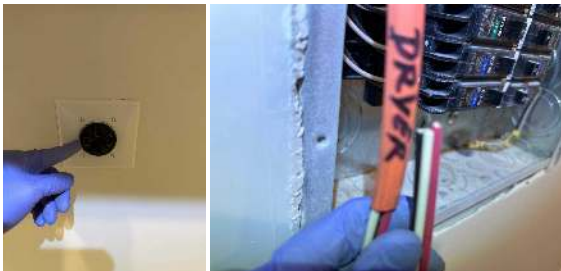
13. ☐ ☐ ☐ ☒ ☐ Washer and Dryer Electrical: 110/ 220. **Disconnected at breaker panel. Evaluation by a licensed electrician is recommended**

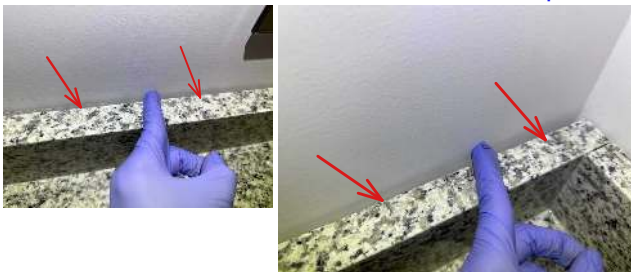
- 20. ☒ ☐ ☐ ☒ ☐ Counter/ Cabinet: Granite counter top and wood - [Caulking missing! , A qualified contractor is recommended to evaluate and estimate repairs](#)

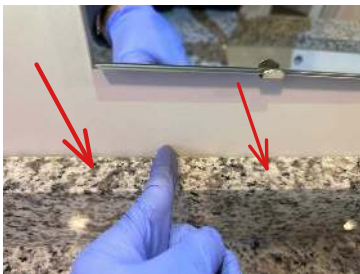
34. ☒ ☐ ☐ ☒ ☐ Counter/ Cabinet: Granite counter top and wood - **Caulking missing!** , A qualified contractor is recommended to evaluate and estimate repairs

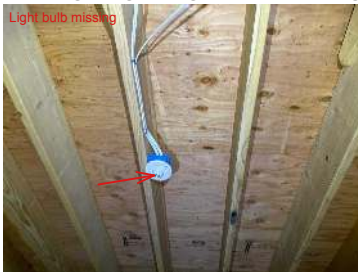
- 7. ☒ ☐ ☐ ☐ ☐ Insulation Depth: 20"
- 8. ☒ ☐ ☐ ☐ ☐ Vapor Barrier: Paper
- 9. ☒ ☐ ☐ ☒ ☐ Wiring/ Lighting: 110 VAC lighting circuit - [Missing light bulbs](#)

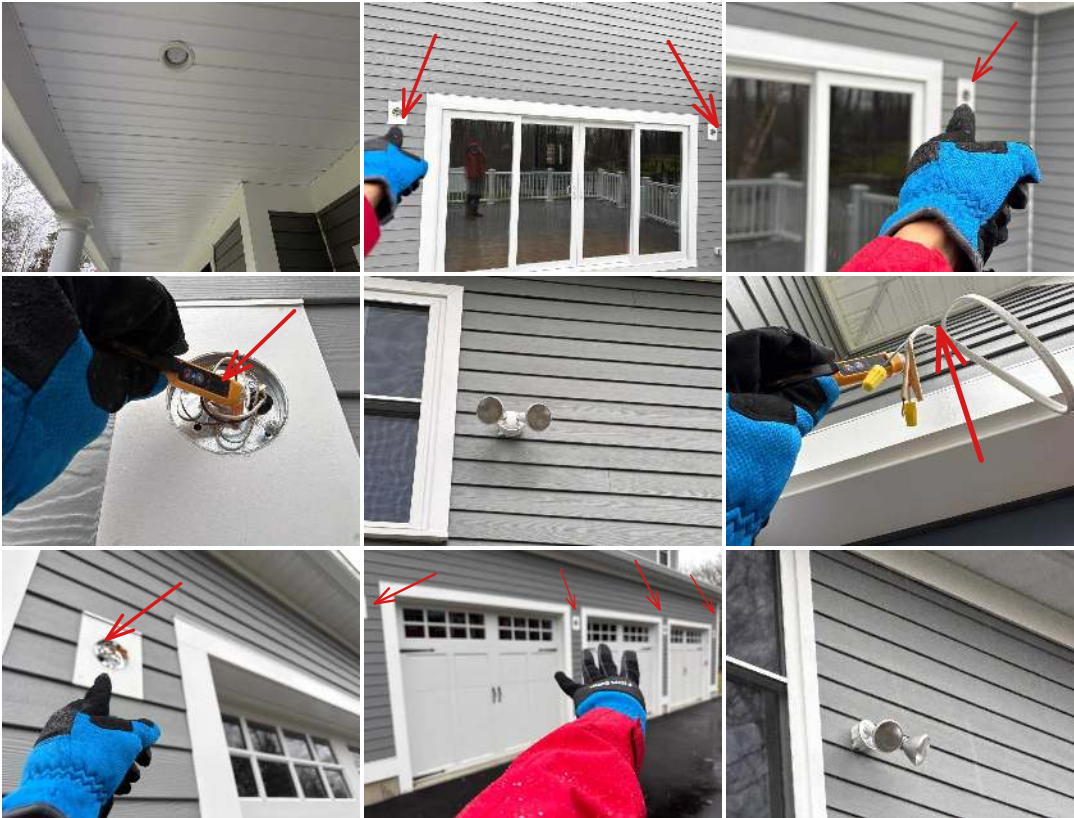
4. Exterior Lighting: Surface mounted lamps front and rear - Exposed wiring at several locations throughout property. Hiring a license electrician is recommended to evaluate and estimate repairs.

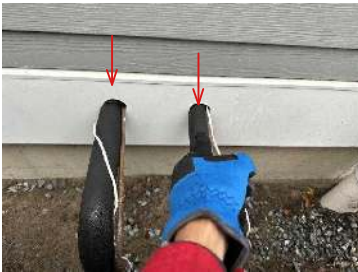
7. Side Of Building AC System Refrigerant Lines: Low pressure and high pressure - [Entry point not sealed!](#)

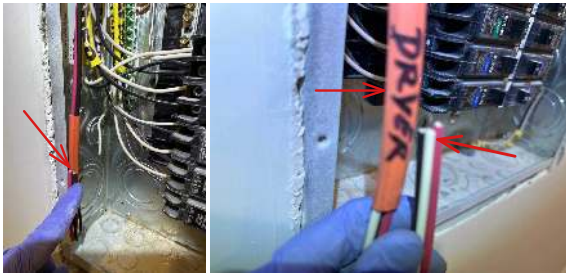
10. Sub Paneling is located in the laundry room Electric Panel Breakers: 12 singles - **Expose wiring missing wire retaining screw cap. Recommend a licensed electrician be hired to evaluate and estimate repair.**

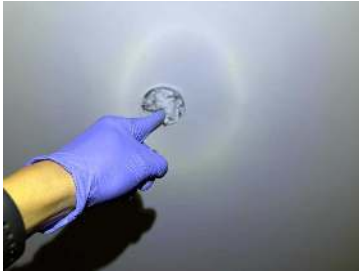
20. Guest 1 Bedroom Electrical: 110 VAC outlets and lighting circuits - [Expose wiring](#) , A licensed electrician is recommended to evaluate and estimate repairs

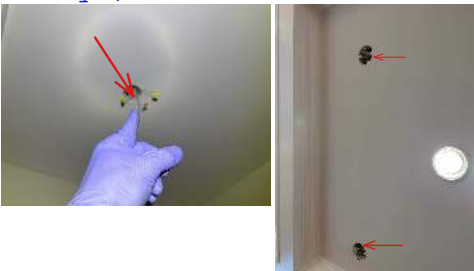
29. In the Kitchen. Kitchen Electrical: 110 GFCI VAC outlets and lighting circuits - [Expose wiring inside pantry](#) , [A licensed electrician is recommended to evaluate and estimate repairs](#)
