# Home Inspection Report

[REDACTED]  
[REDACTED]  
Prepared By: Ramon Marte

15:42 January 06, 2023

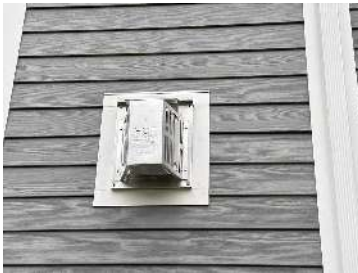
19. ☒ ☐ ☒ ☐ ☐ Chimney: Metal surface mount direct vent - The assessment of the exterior chimney component is limited due to the design or accessibility with area that are beyond the scope of this visual assessment. Recommend a chimney contractor be hired to evaluate.

This chimney will get hot when in use caution should be taken when around this area .

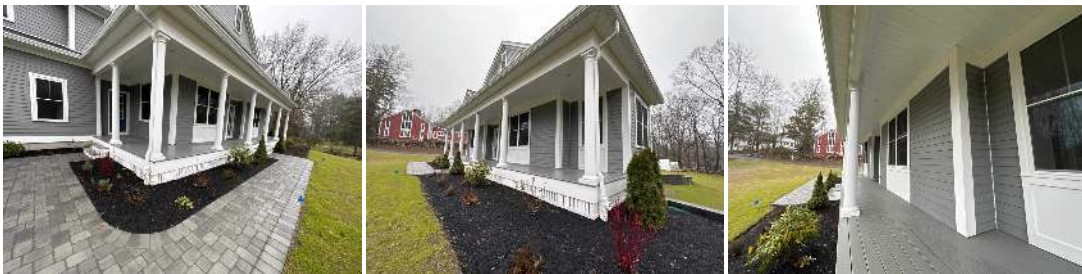
4. ☒ ☐ ☒ ☐ ☐ Porch: Wrapped around porch. There are no access to inspect under framing of the porch due to full secure skirt my comments are based on visible section ONLY, no access to inspect top header which is covered with finish trim those area should also be evaluated by a licensed contractor.

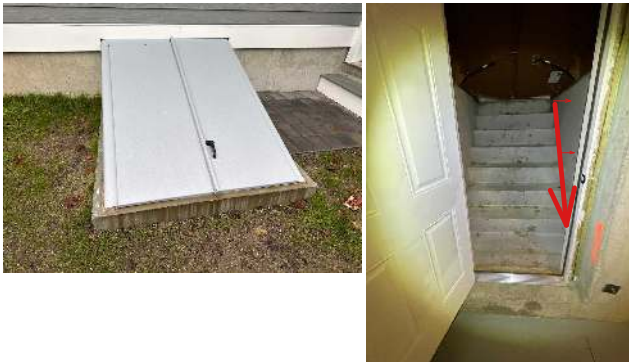
7. ☒ ☒ ☐ ☐ ☐ Balcony: None Present.
8. ☒ ☐ ☐ ☐ ☐ Grading: Minor slope at rear
9. ☐ ☒ ☐ ☐ ☐ Swale: None Present.
10. ☒ ☐ ☐ ☐ ☐ Vegetation: Shrubs / Trees - Monitor vegetation around close perimeter of the house. Leave adequate ventilation and sun exposure to keep the house dry and to protect it from moisture and insect damage.
11. ☐ ☒ ☐ ☐ ☐ Window Wells: None Present.
12. ☐ ☒ ☐ ☐ ☐ Retaining Walls: None Present.
13. ☒ ☐ ☐ ☒ ☐ Basement Stairwell: Concrete - Railings missing (SAFETY), A qualified contractor is recommended to evaluate and estimate repairs.

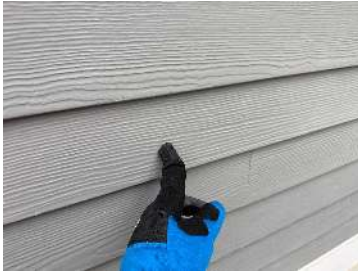
1. ☒☐☐☒☐ Type: Cement Board ( Hardy Planks ). Loose and not caulked. It is good building practice to seal the joints to prevent moisture, such as wind-driven rain and snow, from penetrating the wall cavity. Caulking around windows, doors, eaves and trim edges gives added insurance that leaks will not occur. Recommend a contractor be hired to evaluate and estimate repairs.

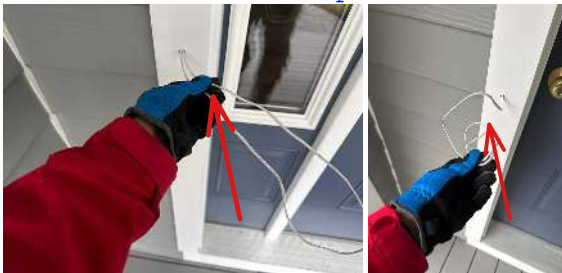
- 2. ☒ ☐ ☐ ☐ ☐ Trim: Composite material
- 3. ☒ ☐ ☐ ☐ ☐ Fascia: Composite material
- 4. ☒ ☐ ☐ ☐ ☐ Soffits: Composite material
- 5. ☐ ☐ ☐ ☒ ☐ Door Bell: Hard wired - [Exposed wires](#)

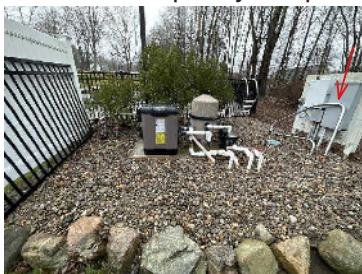
17. Maximum Capacity: 60 Amps
18. ☒ ☐ ☐ ☐ ☐ Main Breaker Size: 60 Amps - [The Main Service is a Breaker, this breaker is properly sized to the service conductor unless otherwise stated.](#)
19. ☒ ☐ ☐ ☐ ☐ Breakers: 1 singles - [Breakers are compatible with conductor material unless stated.](#)
20. ☐ ☒ ☐ ☐ ☐ Fuses: None Present.
21. ☐ ☒ ☐ ☐ ☐ AFCI: None Present.
22. ☒ ☐ ☐ ☐ ☐ GFCI: At GFCI receptacles only
23. Is the panel bonded? ☒ Yes ☐ No
- Sub Paneling is located in the pool pump area Electric Panel \_\_\_\_\_
24. ☒ ☐ ☐ ☐ ☐ Manufacturer: 40 Square D - [Electrical service panel box cover was remove due to rain.](#)
25. Maximum Capacity: Amp

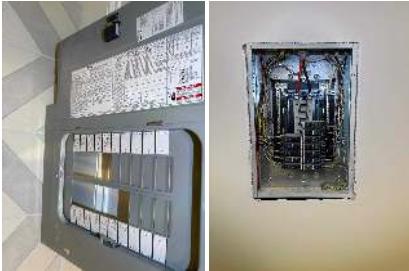
Sub Paneling is located in the laundry room Electric Panel

35. ☐ ☐ ☐ ☒ ☐ Breakers: 12 singles - [Expose wiring missing wire retaining screw cap. Recommend a licensed electrician be hired to evaluate and estimate repair.](#)

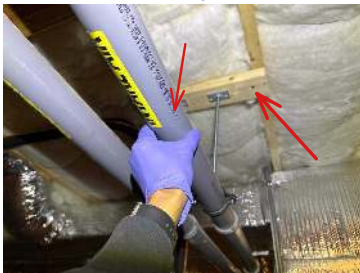
- 10. ☒☐☒☐☐ Distribution: Insulflex duct - My comments are based on visible area only and not duct that are between walls or flooring ETC.
- 11. ☒☐☐☐☐ Draft Control: Automatic
- 12. ☐☐☐☒☐ Flue Pipe: Present - Loose from 2x4 attachment at ceiling , Recommend a contractor be hired to evaluate and repair as needed.

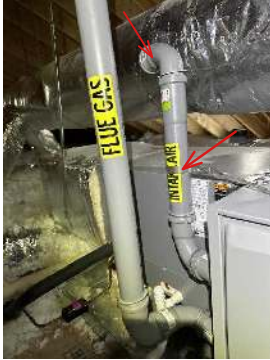
24. ☒ ☐ ☐ ☒ ☐ Draft Control: Automatic - **Not plumb to exterior. Recommend a licensed HVAC Contractor confirm combustion air in attic is sufficient?**

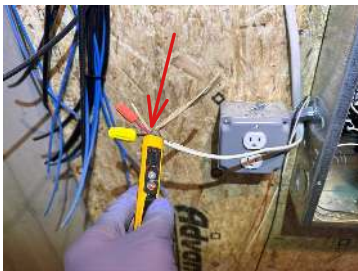
2. ☒ ☐ ☐ ☐ ☐ Walls: Exposed framing
3. ☒ ☐ ☐ ☐ ☐ Floor: Concrete
4. ☐ ☒ ☐ ☐ ☐ Floor Drain: Non Present.
5. ☒ ☐ ☐ ☐ ☐ Doors: Metal
6. ☒ ☐ ☐ ☐ ☐ Windows: Vinyl Slider., Vinyl Double Hung Thermo. Read comments made on basement windows in the Exterior Surface and components section of this report. Recommend windows be made operable for venting.
7. ☐ ☐ ☐ ☒ ☐ Electrical: 110 VAC outlets and lighting circuits - Exposed wiring present. A licensed electrician is recommended to evaluate and estimate repairs

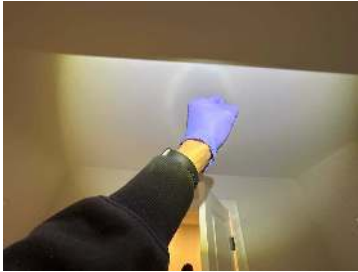
- 14. ☒ ☐ ☐ ☐ ☐ Ceiling: Dry wall finish and painted
- 15. ☒ ☐ ☐ ☐ ☐ Walls: Dry wall finish and painted
- 16. ☒ ☐ ☐ ☐ ☐ Floor: Ceramic tile
- 17. ☒ ☐ ☐ ☐ ☐ Doors: Hollow wood
- 18. ☒ ☐ ☐ ☐ ☐ Windows: Vinyl Double Hung Thermo.
- 19. ☒ ☐ ☐ ☒ ☐ Electrical: 110 GFCI VAC outlets and lighting circuits - [Missing light fixtures , A licensed electrician is recommended to evaluate and estimate repairs](#)

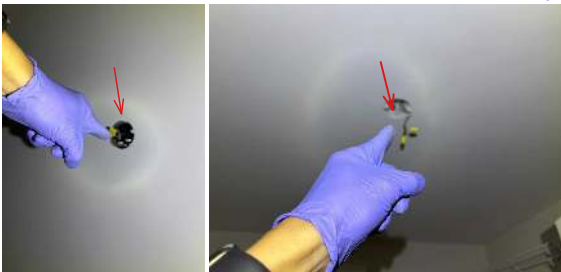
2. ☒ ☐ ☐ ☐ ☐ Ceiling: Dry wall finish and painted  
 3. ☒ ☐ ☐ ☐ ☐ Walls: Dry wall finish and painted  
 4. ☒ ☐ ☐ ☐ ☐ Floor: Hard wood flooring  
 5. ☒ ☐ ☐ ☐ ☐ Doors: Hollow wood  
 6. ☒ ☐ ☐ ☐ ☐ Windows: Vinyl Double Hung Thermo., Vinyl Awning thermo.  
 7. ☒ ☐ ☐ ☒ ☐ Electrical: 110 VAC outlets and lighting circuits - **Exposed wiring , A licensed electrician is recommended to evaluate and estimate repairs**

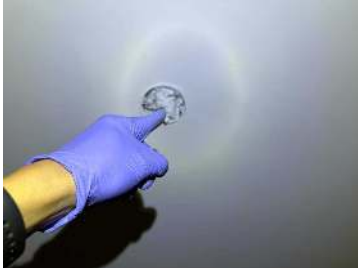
- 11. ☒ ☐ ☐ ☐ ☐ Ceiling: Dry wall finish and painted
- 12. ☒ ☐ ☐ ☐ ☐ Walls: Dry wall finish and painted
- 13. ☒ ☐ ☐ ☐ ☐ Floor: Hard wood flooring
- 14. ☒ ☐ ☐ ☐ ☐ Doors: Hollow wood
- 15. ☒ ☐ ☐ ☐ ☐ Windows: Vinyl Double Hung Thermo., Vinyl Awning thermo.
- 16. ☒ ☐ ☐ ☒ ☐ Electrical: 110 VAC outlets and lighting circuits - [Expose wiring , A licensed electrician is recommended to evaluate and estimate repairs](#)

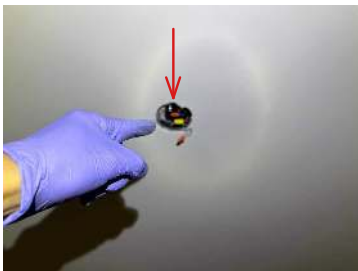
29. ☒ ☐ ☐ ☐ ☐ Ceiling: Dry wall finish and painted
30. ☒ ☐ ☐ ☐ ☐ Walls: Dry wall finish and painted
31. ☒ ☐ ☐ ☐ ☐ Floor: Hard wood flooring
32. ☒ ☐ ☐ ☐ ☐ Doors: Hollow wood
33. ☒ ☐ ☐ ☐ ☐ Windows: Vinyl Double Hung Thermo.
34. ☒ ☐ ☐ ☒ ☐ Electrical: 110 VAC outlets and lighting circuits - [Close wiring , A licensed electrician is recommended to evaluate and estimate repairs](#)

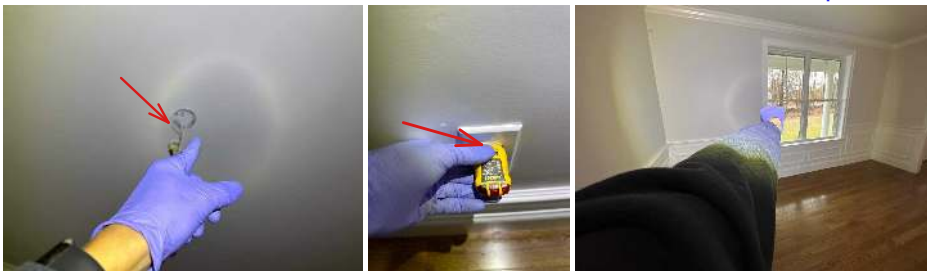
7. ☐ ☐ ☐ ☒ ☐ Electrical: 110 VAC outlets and lighting circuits - **Expose wiring no power is active in this room. A licensed electrician is recommended to evaluate and estimate repairs**

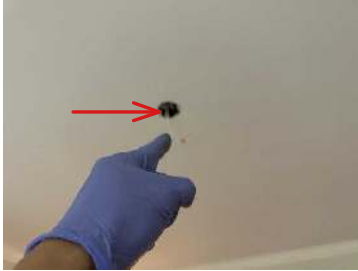
25. ☐ ☐ ☐ ☒ ☐ Electrical: 110 VAC outlets and lighting circuits - [Expose wiring, A licensed electrician is recommended to evaluate and estimate repairs](#)

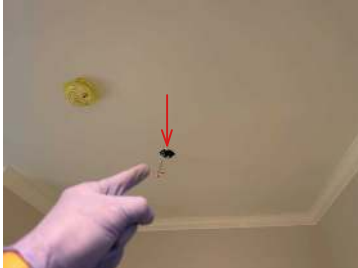
43. ☐ ☐ ☐ ☒ ☐ Electrical: 110 VAC outlets and lighting circuits - [Expose wiring , A licensed electrician is recommended to evaluate and estimate repairs](#)

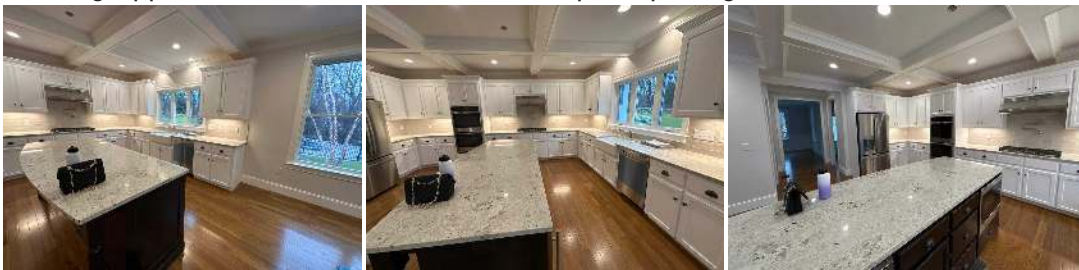
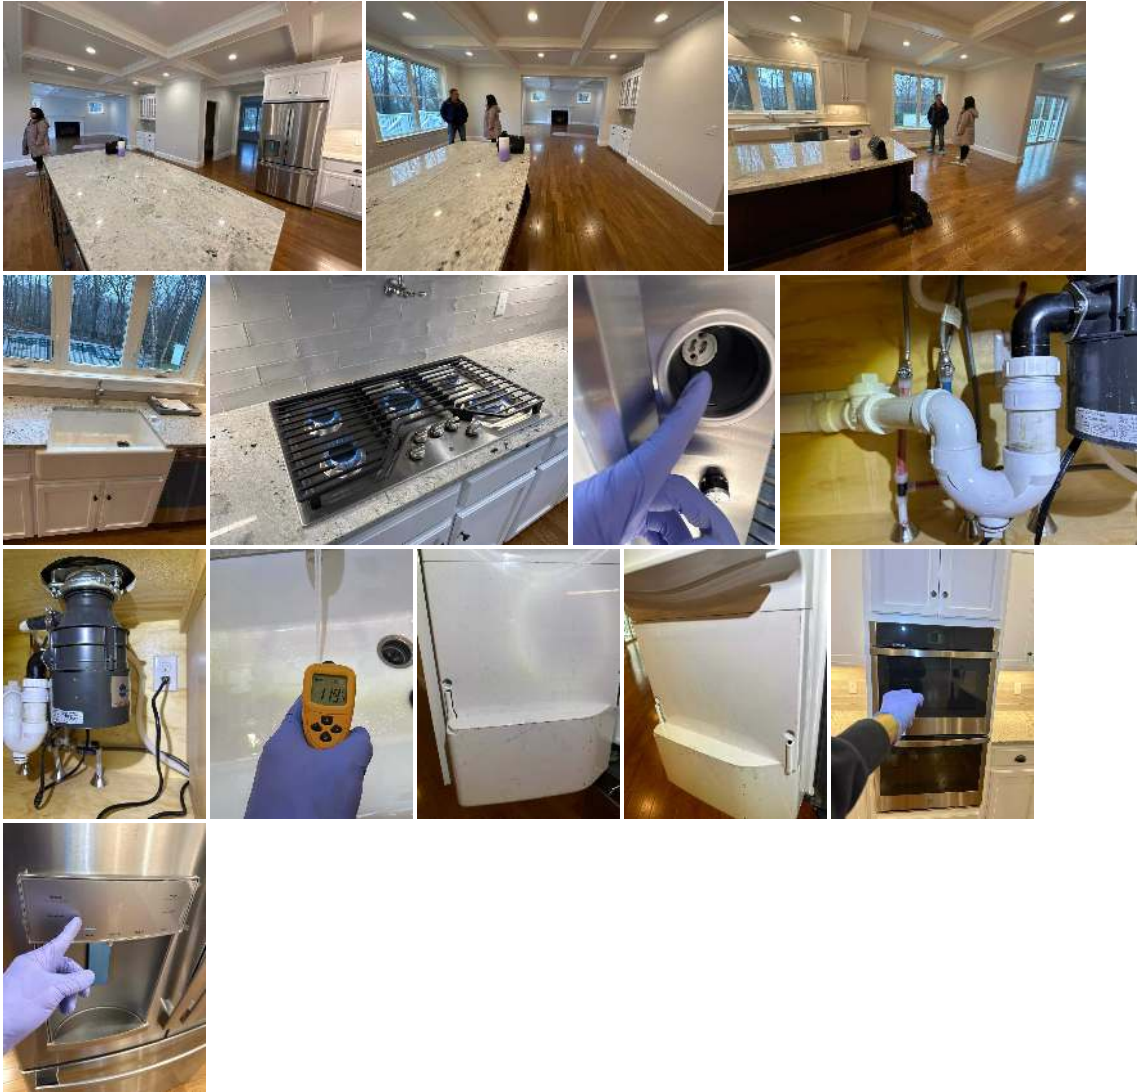
1. ☒ ☐ ☐ ☐ ☐ Cooking Appliances: General Electric, Cook top- Propane gas

2. ☒ ☐ ☐ ☐ ☐ Ventilator: Over the Range Hood. **Over the Range Microwave but not vented to exterior,**
3. ☒ ☐ ☐ ☐ ☐ Disposal: Badger 3/ 4 HP.
4. ☒ ☐ ☐ ☐ ☐ Dishwasher: Dish washer is Stainless Steel., General Electric - **Ran dishwasher through full cycle during home inspection, no leaks.**
5. ☐ ☒ ☐ ☐ ☐ Trash Compactor: None Present.

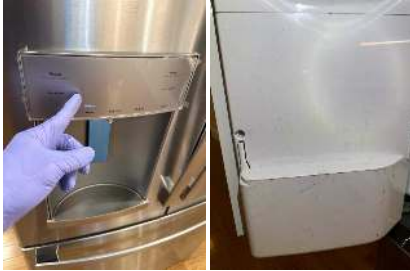
6. ☐☐☐☒☐ Refrigerator: Refrigerator is Stainless Steel., General Electric - No water or ice connections.

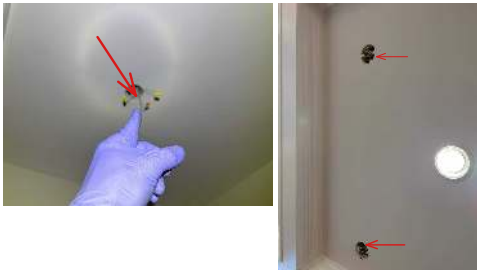
9. ☒☐☐☒☐ Electrical: 110 GFCI VAC outlets and lighting circuits - Expose wiring inside pantry , A licensed electrician is recommended to evaluate and estimate repairs

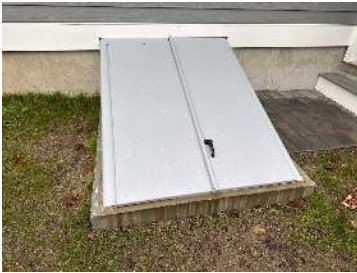
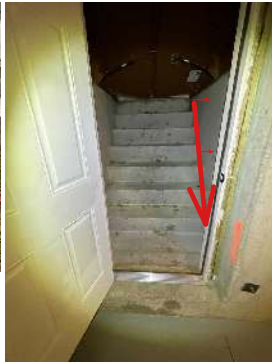
1. Basement Stairwell: Concrete - Railings missing (SAFETY), A qualified contractor is recommended to evaluate and estimate repairs.

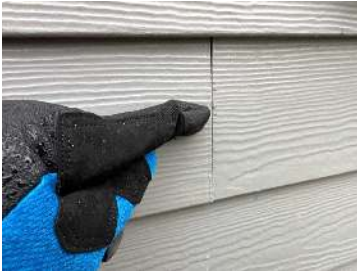
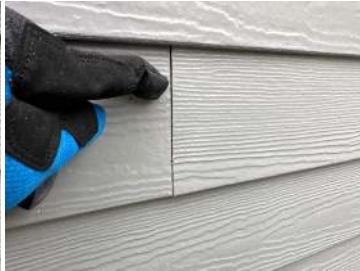
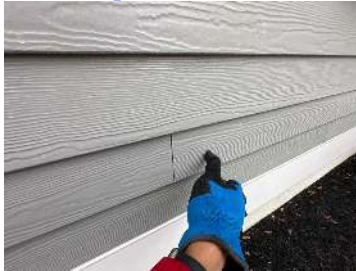
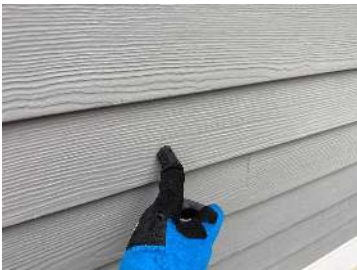
2. Main. Exterior Surface Type: Cement Board ( Hardy Planks ). Loose and not caulked. It is good building practice to seal the joints to prevent moisture, such as wind-driven rain and snow, from penetrating the wall cavity. Caulking around windows, doors, eaves and trim edges gives added insurance that leaks will not occur. Recommend a contractor be hired to evaluate and estimate repairs.

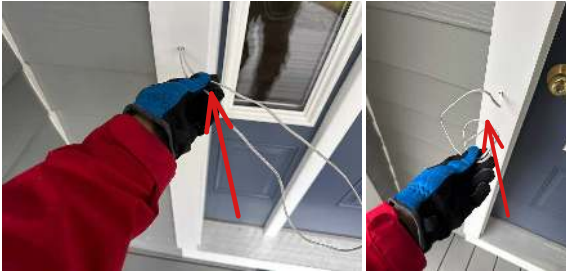
3. Door Bell: Hard wired - Exposed wires

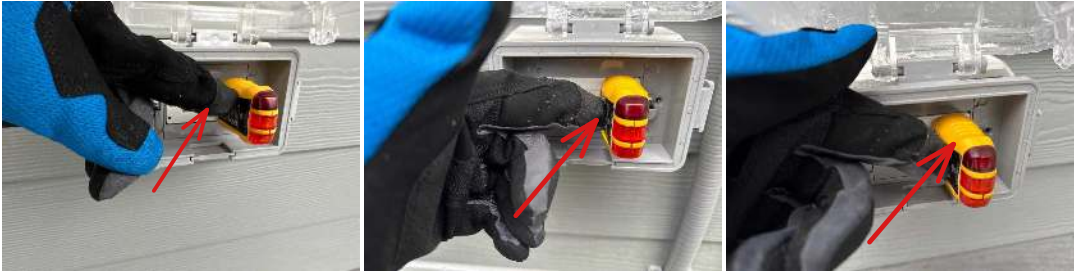
5. Exterior Electric Outlets: 110 VAC GFCI - Outlet would not reset when tripped and tested, Confirm at electrical panels no tripped breakers? recommend a license electrician be hired to evaluate and estimate repairs.

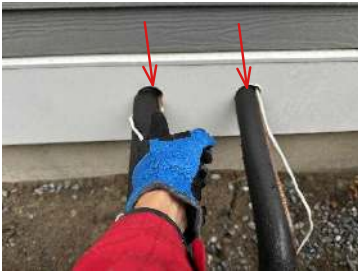
6. Side Of Building AC System Refrigerant Lines: Low pressure and high pressure - [Entry point not sealed!](#)

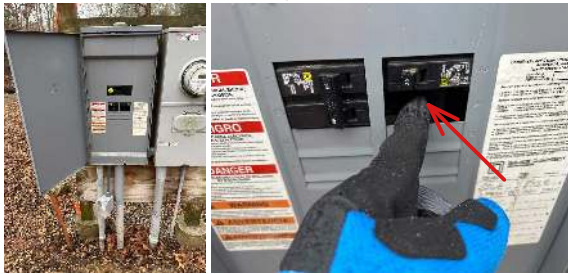
9. Sub Paneling is located in the exterior Electric Panel Manufacturer: Square D - [Open knock-out hole- insert blank-out cap to close off opening.](#) [Evaluation by a licensed electrician is recommended](#)

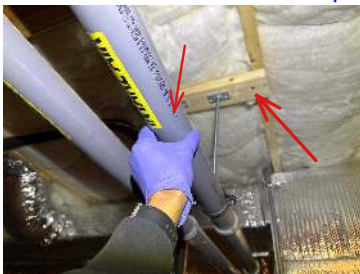
11. Basement Heating System Flue Pipe: Present - **Loose from 2x4 attachment at ceiling , Recommend a contractor be hired to evaluate and repair as needed.**

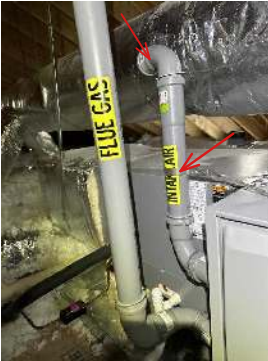
12. Basement Heating System Draft Control: Automatic - **Not plumb to exterior. Recommend a licensed HVAC Contractor confirm combustion air in attic is sufficient?**

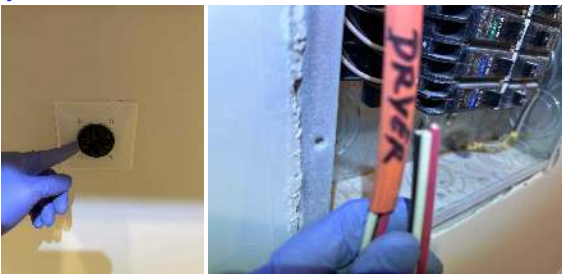
13. 2nd Floor Laundry Room/ Area Washer and Dryer Electrical: 110/ 220. [Disconnected at breaker panel. Evaluation by a licensed electrician is recommended](#)

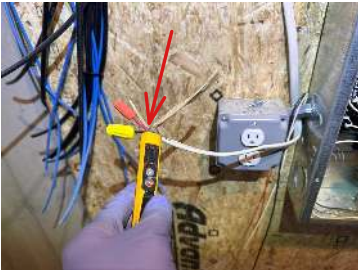
14. Main Basement Electrical: 110 VAC outlets and lighting circuits - [Exposed wiring present. A licensed electrician is recommended to evaluate and estimate repairs](#)

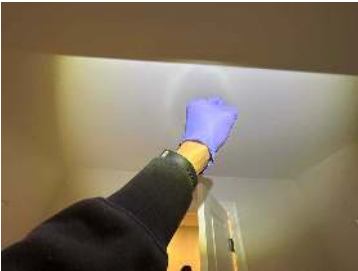
16. 2nd floor main Bathroom Electrical: 110 GFCI VAC outlets and lighting circuits - [Missing light fixtures](#) , [A licensed electrician is recommended to evaluate and estimate repairs](#)

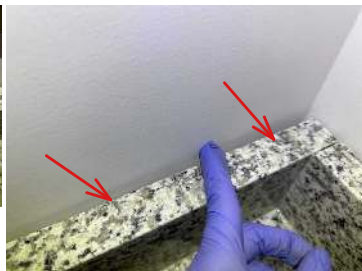
- 20. ☒ ☐ ☐ ☒ ☐ Counter/ Cabinet: Granite counter top and wood - [Caulking missing! , A qualified contractor is recommended to evaluate and estimate repairs](#)

17. 2nd floor main Bathroom Counter/ Cabinet: Granite counter top and wood - [Caulking missing!](#) , [A qualified contractor is recommended to evaluate and estimate repairs](#)

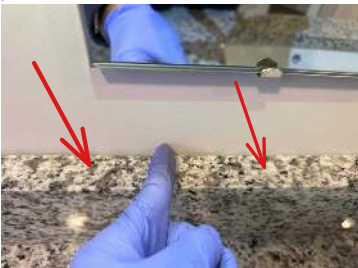
34. ☒ ☐ ☐ ☒ ☐ Counter/ Cabinet: Granite counter top and wood - **Caulking missing!** , A qualified contractor is recommended to evaluate and estimate repairs

18. 2nd floor guest bedroom Bathroom Counter/ Cabinet: Granite counter top and wood - [Caulking missing!](#) , [A qualified contractor is recommended to evaluate and estimate repairs](#)

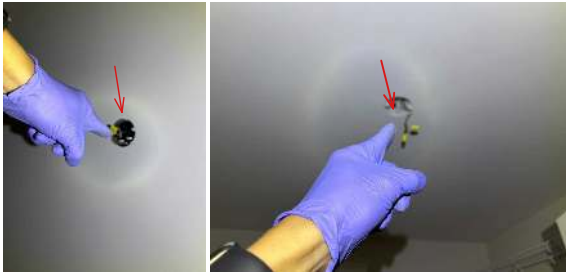
19. Primary Bedroom Electrical: 110 VAC outlets and lighting circuits - [Exposed wiring](#) , A licensed electrician is recommended to evaluate and estimate repairs

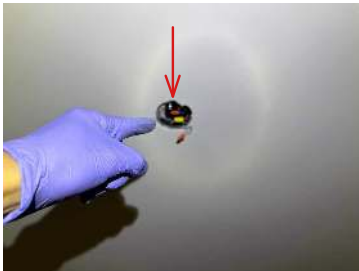
22. Guest 3 Bedroom Electrical: 110 VAC outlets and lighting circuits - [Close wiring](#) , A licensed electrician is recommended to evaluate and estimate repairs

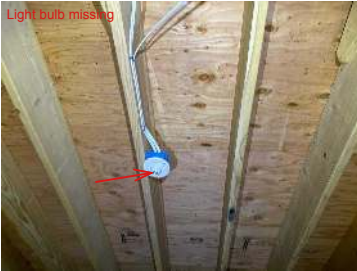
- 7. ☒ ☐ ☐ ☐ ☐ Insulation Depth: 20"
- 8. ☒ ☐ ☐ ☐ ☐ Vapor Barrier: Paper
- 9. ☒ ☐ ☐ ☒ ☐ Wiring/ Lighting: 110 VAC lighting circuit - [Missing light bulbs](#)

23. Main Attic Wiring/ Lighting: 110 VAC lighting circuit - [Missing light bulbs](#)

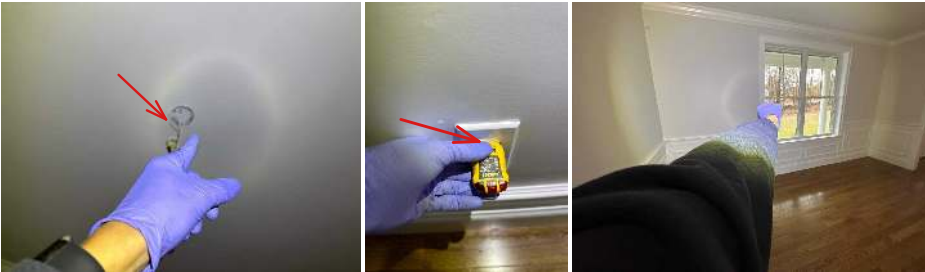
24. Living Room Living Space Electrical: 110 VAC outlets and lighting circuits - [Expose wiring no power is active in this room. A licensed electrician is recommended to evaluate and estimate repairs](#)

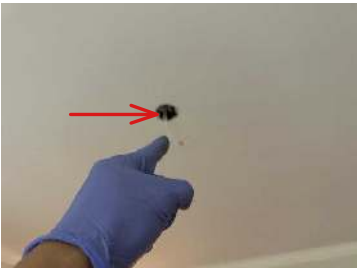
26. Dining Room Living Space Electrical: 110 VAC outlets and lighting circuits - [Expose wiring, A licensed electrician is recommended to evaluate and estimate repairs](#)

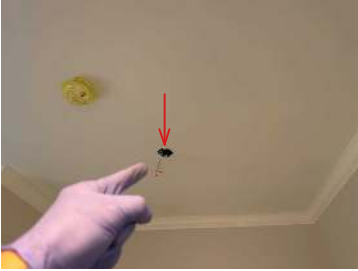
27. Mud Room Living Space Electrical: 110 VAC outlets and lighting circuits - [Expose wiring](#) , [A licensed electrician is recommended to evaluate and estimate repairs](#)

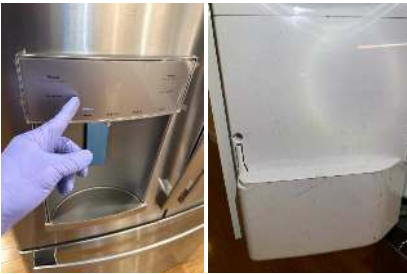
28. In the Kitchen. Kitchen Refrigerator: Refrigerator is Stainless Steel., General Electric - [No water or ice connections.](#)
